A METALLURGICAL STUDY OF GERMAN AND ITALIAN AIRCRAFT ENGINE AND AIRFRAME PARTS

By
THE AERO COMPONENTS SUB-COMMITTEE
of the
TECHNICAL ADVISORY COMMITTEE
to the
SPECIAL AND ALLOY STEELS COMMITTEE

Arranged, in co-operation with the Committee,
by CHARLES A. OTTO, Editor of *METALLURGIA*.

Published by
THE KENNEDY PRESS LTD.,
21, Albion Street, Manchester, 1,
and Bedford Street, London, W.C.2.
1943.

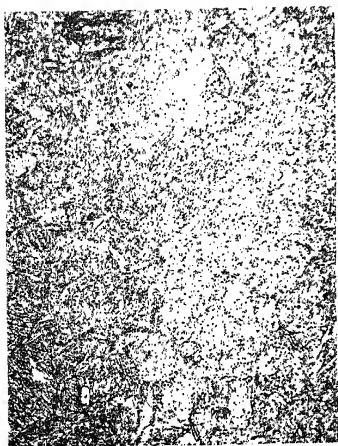
Fig. 33.—Microstructure of Jumo 211A double big-end rod. x 200.
